REPORT BMS68

Performance Test of
Floor Coverings for Use in
Low-Cost Housing: Part 3

PERCY A. SIGLER
and ELMER A. KOERNER

NATIONAL
BUREAU OF STANDARDS

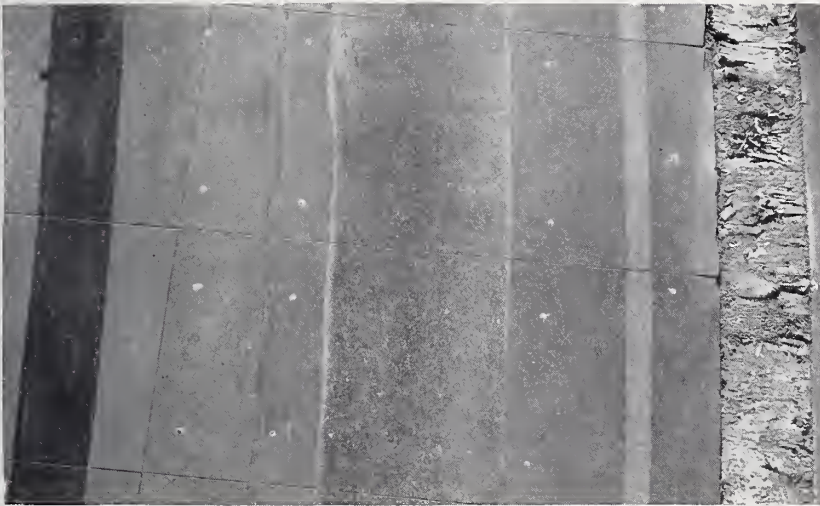
FIGURE 25.— $\frac{1}{8}$ -in. asphalt tile
on plywood subfloor (test
panel 12L).

The $\frac{1}{8}$ -in. and the $\frac{3}{16}$ -in. asphalt tiles showed fair performance on a concrete subfloor (see figs. 23, 24, 27, and 29). They were pitted and worn to a moderate degree by the steel-tired truck wheel (see table 1). The $\frac{1}{8}$ -in. asphalt tiles on Douglas fir plywood subfloors with no underlay, panels 12L and 12R, showed fair performance except under the action of the steel-tired truck wheel, which crushed the tiles completely (see figs. 25 and 26). The $\frac{3}{16}$ -in. asphalt tiles on a strip-wood subfloor with an underlay of felt, panels 14L and 14R, did not stand up well in this test. The tiles were crushed by the steel-tired truck wheel and were fractured to an appreciable degree by the walking wheel (see figs. 28 and 30). In general, the asphalt tiles were worn to a moderate degree by the abrasive action of the walking wheel (see table 2).
